Accessibility for persons with mobility impairments within an informal trading site: A case study on the markets of Warwick, South Africa

Objectives: This case study aimed at exploring accessibility within the markets of Warwick for persons with mobility impairments by an ergonomic assessment, augmented by voices of participants within the market.

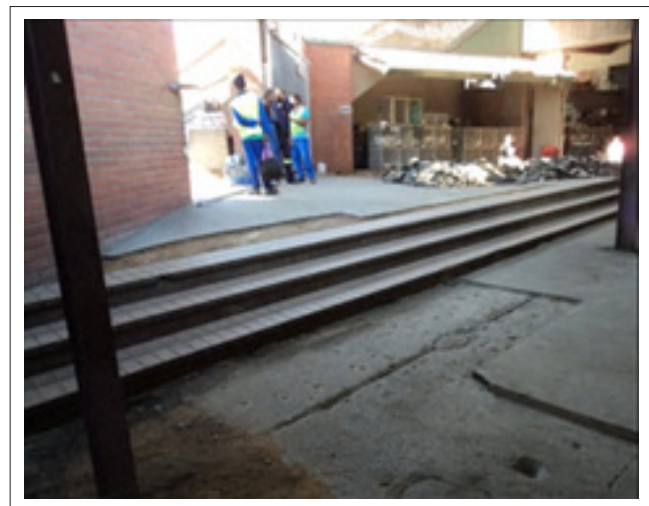
FIGURE 3: Entrance with no handrails on either side of the staircase.

The environmental survey raised various issues related to access points (such as roads, staircases, bridges, ramps and sidewalks) to the nine markets. These included the quality of the ramps and stairs (including handrails), sidewalks and road surfaces leading to these access points. Ramps and certain stairs failed to meet the standard safety requirements (Figure 3).

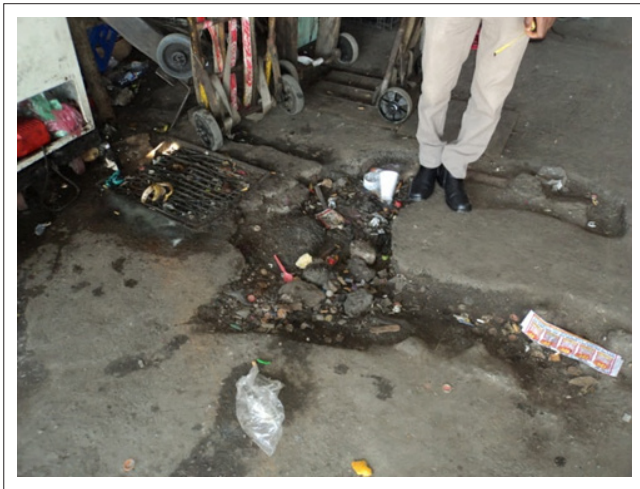
Doorways exceed the standard requirement, namely 750 mm width (SANS 10400-S 2011: section 4.6) and participants, therefore, reported no difficulties moving through the doorways and entrances to the markets. Surrounding sidewalks leading to access points were in a poor state, with many potholes and uneven floor surfaces being noted (Figure 4).

Potholes were often filled with litter and broken glass, posing health and safety risks for persons using wheelchairs. Whilst several sidewalks leading to access points met the design specification of 1500 mm in width, some traders occupied most of the sidewalk space to display their goods. This inevitably leaves limited space for persons with mobility impairments, especially those utilising wheelchairs, as there is no alternative accessible and safe route (SANS 10400-S 2011: section 4.4). These poorly conditioned sidewalk surfaces and limited spaces often result in wheelchair users mobilising on the road to access the markets and/or taxi services (Figure 5). 'The road

FIGURE 4: Pothole (120 mm deep and 530 mm wide).

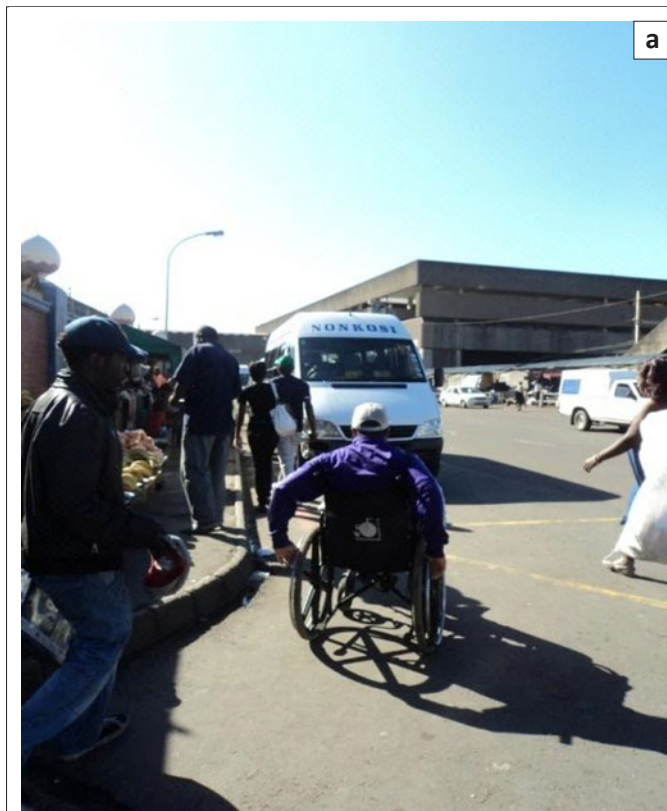
FIGURE 5: Wheelchair user accessing a taxi from the road.

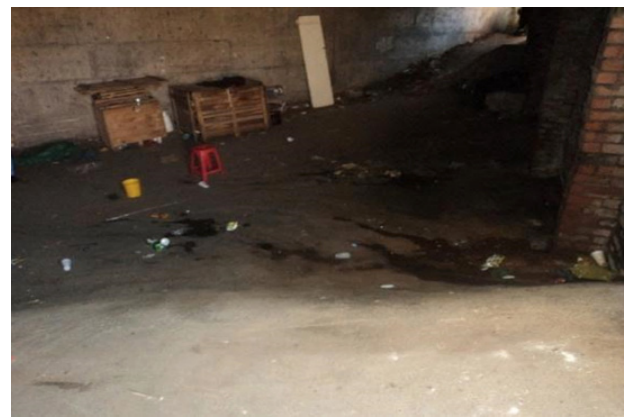
Subsequently, this storage facility has been abandoned, and is now used as an ablution facility, which poses a health risk to traders and consumers (Figure 6).

FIGURE 6: Abandoned storage facility located outside the bead market utilised as an ablution facility.

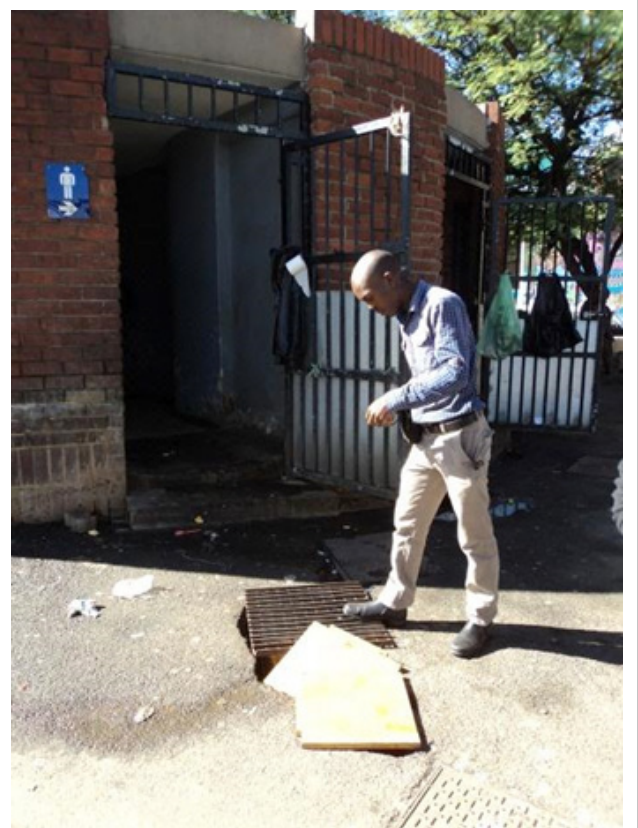
The environmental survey revealed poor terrain for mobilisation (for example, open manholes and large potholes), presenting difficulties and potential danger for those wanting to access the facilities (Figure 7).

The entrance to the ablution facility does not have a ramp; it, however, does have steps and therefore access for those persons with mobility impairments is hindered. Moreover, the ablution facilities surrounding the markets are not accessible to consumers after 16:00. Although this is considered 'rush hour' with many persons passing through the area (as a thoroughfare) after their working

FIGURE 7: Entrance of public ablution facility with large pothole covered with wood, and absence of ramp leading into ablution facility.

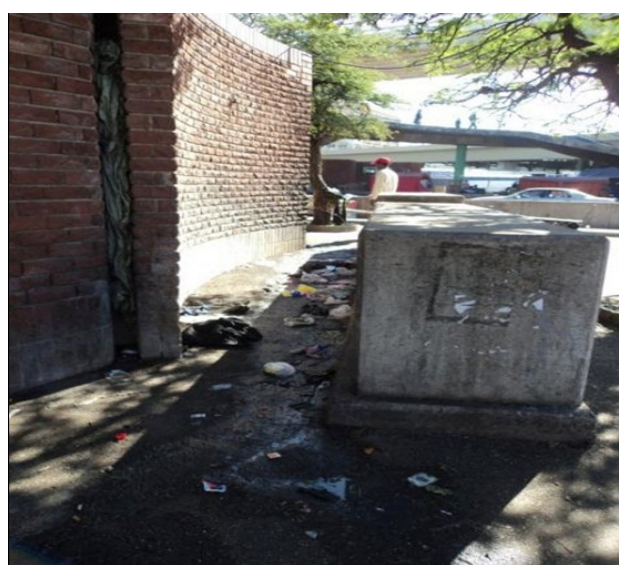
day, these facilities remain locked. As a consequence, persons needing to use the ablution facilities, utilise public stall areas as an 'ablution facility' (Figure 8).

The stall situated behind the ablution facilities in two of the markets has, hence, become a severe health risk because of urine and faeces on sidewalks which run into the surrounding drains.

FIGURE 8: Area used as ablution facility when public ablution facilities are closed after 16:00 daily.

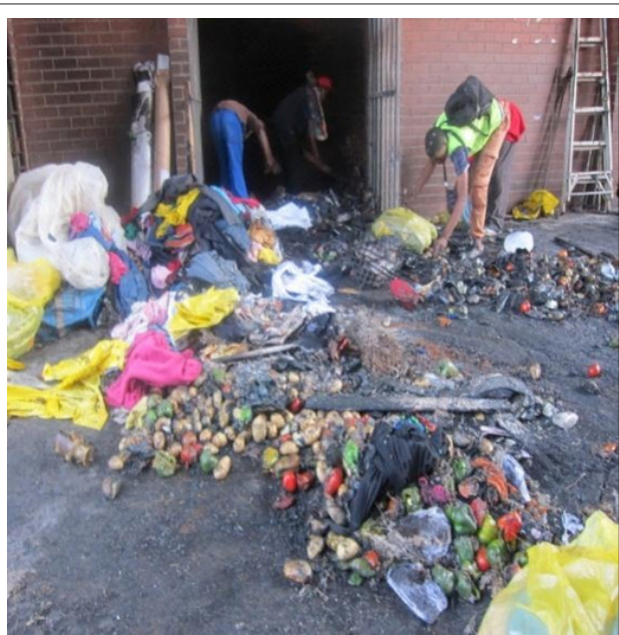
in an emergency situation. Lastly, as already mentioned, severe health risks flow from utilising certain areas for ablution which were not designated for ablution use. In the extreme and unfortunate case of a fire or an emergency requiring fast exit from the markets, factors one to three will reduce the ability of persons with mobility impairments utilising the markets to exit buildings (Figure 9).

FIGURE 9: Recent fire damage resulting in loss of trader goods and damage to storage facilities.

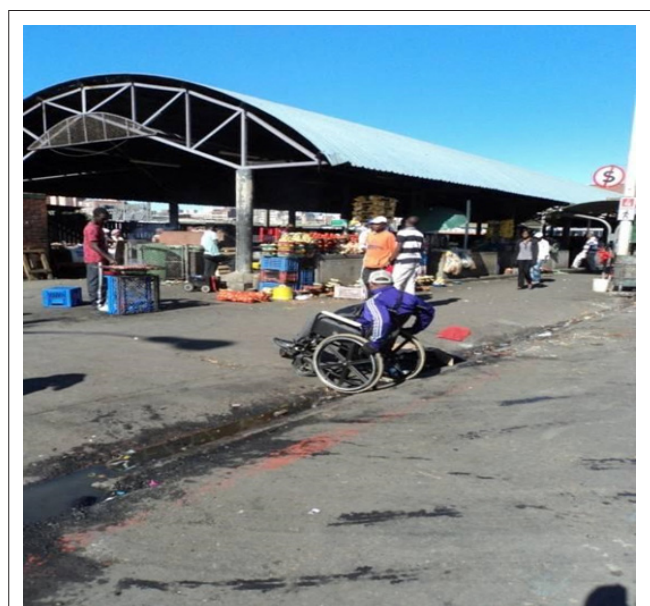
Participants also appeared to be unfamiliar with the context of designated disability parking bays within and surrounding the markets. The environmental survey revealed parking facilities available and accessible to only three of the nine markets, two of which have parking facilities available for both traders and consumers. There are a number of taxi pick-up zones which are located around the nine markets with each taxi zone servicing different geographical areas. According to the participants, they travel to the markets by public transport, more specifically taxis, and arrive and depart in close proximity to the market area (Figure 10).

FIGURE 10: Wheelchair user observed crossing Market Avenue from pick-up zone located on opposite side of the road.
